DATING OF SOME HISTORICAL SAFRANBOLU HOUSES WITH DENDROCHRONOLOGICAL METHODS

Abstract

Keywords: Historical Safranbolu Houses, Dendrochronology, Dating.

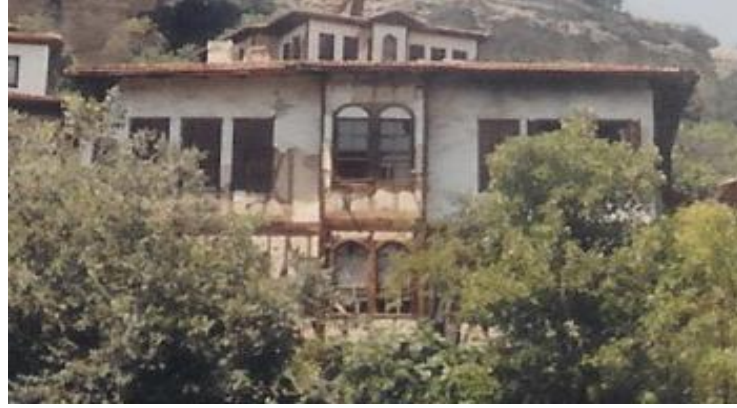
Figure 2. Front view of the building numbered 1.

The house in Figure 2. is in Safranbolu Eski Çarşı Celal Bayar Caddesi Akçasu Mahallesi No: 24 and not suitable for accommodation. 10 samples were taken from that building these are balcony pillar, supporter, beam materials.

main chronology of Karabük Blackpine coded 2PINI (EUY %65.4***), Building 1 was dated back to 1800-1894. With respect to this result the wood used for the construction of this house dated back as the closest time to 1894. Since the samples were finished and lack of the latest rings, it could be said that that building might have been constructed after that date (1894).

Building 1 located in Eski Çarşı region Celal Bayar Street has got 3 storeys. The number of researched samples was 7 as seen on Table 1 the concordance among the samples was quite high. With respect to this correlation their mean value was taken. After making a comparison on the main chronology of Karabük-karaçam (Blackpine) coded 2PINI (EUY %65.4***), the house numbered 1 was dated back to 1800-1894. This result certified that the construction date was about in 1896, the building and the fountain was built at the same time.

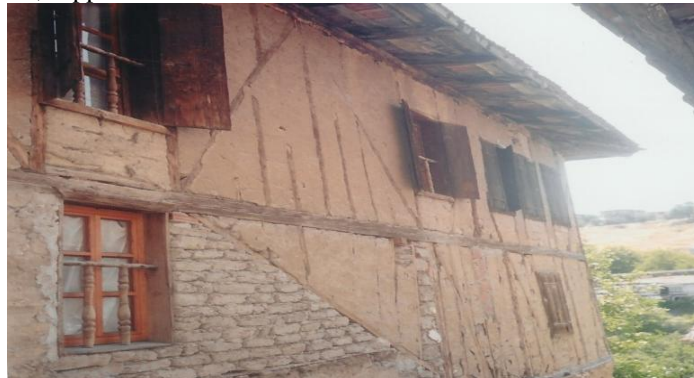
Figure 3. Side view of the house numbered 2.

The house in Figure 3. is in Eski Çarşı Dışkalealtı sokak No: 17 with 2 storeys. There are barns, a huge fireplace for kitchen range and a granary on the ground floor. 10 samples were taken from this building. These samples were stair, supporter and window frame materials.

After taking the average values of the samples and being coded as Building 2, a comparison was made on the main chronology of Karabük Blackpine coded 2PINI (EUY %68.5***), Building 2 was dated back to 1810-1891. With respect to this result the wood used for the construction of this house dated back as the closest time to 1891. Since the samples were finished and lack of the latest rings, it could be said that that building might have been constructed after that date (1891).

The house numbered 2 located in Kalealtı street has got 1 storey. The number of researched samples was three. After making a comparison on the main chronology of Karabük karaçam (Blackpine) coded 2PINI (EUY %68.5***), the building was dated back to 1890-1891. This result shows that it was built as the closest time in 1891. The house located in the same area with Hükümet Konağı built in 1904. Kalealtı Primary school 50 m. far from the house was built in 1908. The house numbered 2 and the other two buildings the construction date of which were very close to each other were also located in the same area.

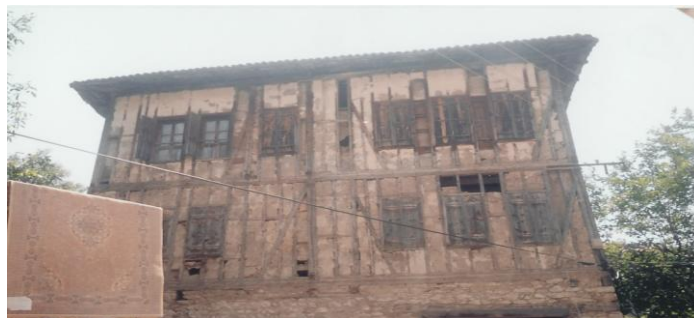
Figure 4. Front view of the house numbered 3.

Figure 4. belongs to the house with 3 storeys in Safranbolu Eskiçarsi Celal Bayar cad. Eflani sokak No: 2 and it has still been accommodated. There is a depot for heating materials (firewood) and a warehouse on the ground floor. Food for the winter is stored on the first and second floor. 10 samples were taken; these samples were supporter, beam, roof and window frame materials.

After taking the mean values of the samples and being coded as Building 3, a comparison was made on the main chronology of Karabük Blackpine coded 2PINI (EUY %67.8***), Building 3 was dated back to 1848-1893. With respect to this result the wood used for the construction of this house dated back as the closest time to 1893. Since the samples were finished and lack of the latest rings, it could be said that that building might have been constructed after that date (1893).

Building 3 located in Eski Çarşı Çeşme region Celal Bayar caddesi Eflani sokak has got three storeys and it has still been accommodated. The number of the researched samples was three. The concordance among the samples was quite high so their mean values were calculated.

After making a comparison on the main chronology of Karabük-karaçam coded 2PINI (EUY %67.8***), the house was dated back to 1893. The closest construction date of that house could be in 1893. It is in the same location with Kadı Efendi fountain built in 1896. Also the location of this building and building 3 are very close. The construction date of them is 1893-1891. There is no significant difference between the dates.

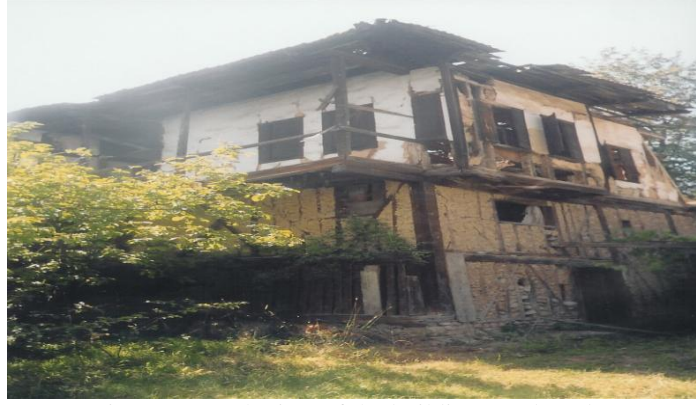
Figure 5. North view of the building numbered 4.

Figure 5. belongs to the house with 2 storeys in Safranbolu Baglar Mah. Degirmenbasi sokak No: 35. This house is semi damaged and is not accommodated. There is a warehouse and a depot on the ground floor. 10 samples were taken from the building. These were supporters, beam, roof and window frame materials.

After taking the average values of the samples and being coded as Building 4, a comparison was made on the main chronology of Karabük Blackpine coded 2PINI (EUY %65.6***), Building 4 was dated back to 1838-1883. With respect to this result the wood used for the construction of this house dated back as the closest time to 1883. Since the samples were finished and lack of the latest rings, it could be said that that building might have been constructed after that date (1883).

The house numbered 4 with 2 storeys is in Değirmenbaşı Street. 6 samples were taken. The correlation among the samples was quite high so their mean value was taken. After making a comparison on the main chronology of Karabük-karaçam (Blackpine) coded 2PINI (EUY %65.6***), the building was dated back to 1838-1883. It proved that the closest construction date of the building could be in 1883. It could also be the date of restoration.

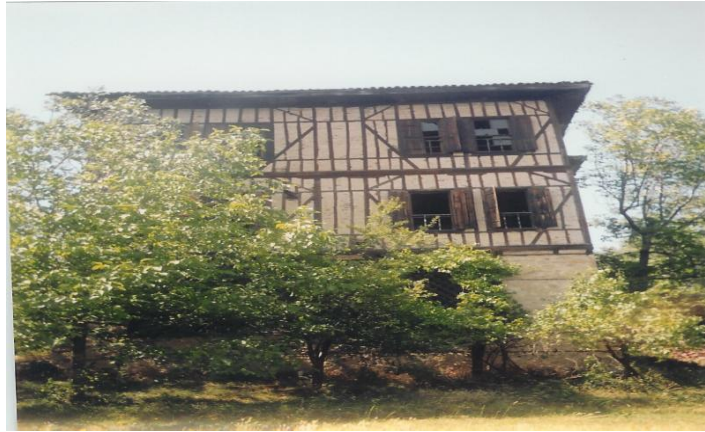
Figure 6. North view of the house numbered 5.

The house with 3 storeys in Figure 6. is in Safranbolu Baglar mah, Hacibey sok. No: 30. It is possible to see the best samples of Safranbolu wooden architecture in that building. These were supporter, beam, sofa and window frame materials.

After taking the average values of the samples and being coded as Building 5, a comparison was made on the main chronology of Karabük Blackpine coded 2PINI (EUY %72.2***), Building 5 was dated back to 1899-1953. With respect to this result the wood used for the construction of this house dated back as the closest time to 1953. Since the samples were finished and lack of the latest rings, it could be said that that building might have been constructed after that date (1953).

Building 5 is located in Bağlar region Hacı Bey Lane and it has got 4 storeys. 5 samples were taken the correlation among the samples was quite high so their mean values were calculated. After making a comparison on the main chronology of Karabük-karaçam (Blackpine) coded 2PINI (EUY %57.2***), the building was dated back to 1899-1953. 1953 was the closest construction date of it. It could also be the date of restoration.

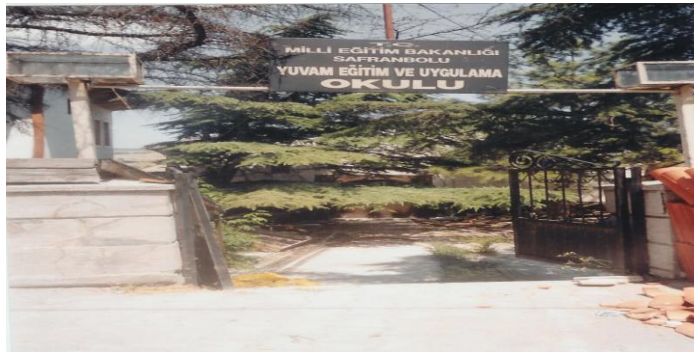
Figure 7. Front view of the house numbered 6.

The building in Figure 7. is in Safranbolu Kirankoy Inonu mah. Okul sok. No: 9 with 1 storey. 10 samples were taken from that house. These were supporter beam window frame and roof materials.

After taking the average values of the samples and being coded as Building 6, a comparison was made on the main chronology of Karabük Blackpine coded 2PINI (EUY %69.2***), Building 6 was dated back to 1732-1822. With respect to this result the wood used for the construction of this house dated back as the closest time to 1953. Since the samples were finished and lack of the latest rings, it could be said that that building might have been constructed after that date (1822).

Building 6 with 1 storey is located in Safranbolu Kıranköy İnönü mah. Okul cad. 7 samples were taken, the correlation among the sample was quite high so their mean values were taken. After making a comparison on the main chronology of Karabük-karaçam (Blackpine) coded 2PINI (EUY %69.2***), the building was dated back to 1732-1822. 1822 could be the closest construction date of it. It is located in the same area with Abdi Çavuş fountain. The fountain was built in 1813. Their construction date of the buildings was very close to each other.

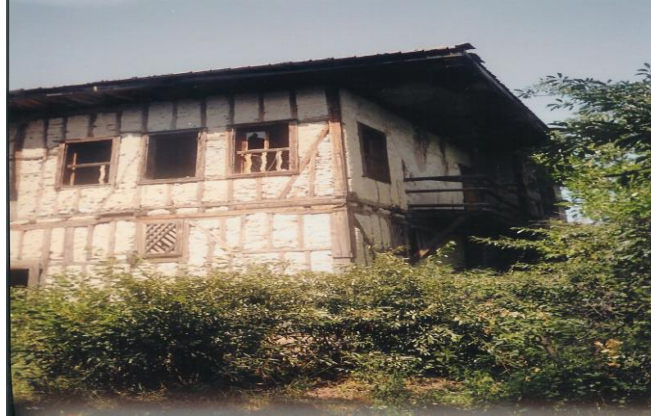
Figure 8. Side view of the house numbered 7.

The house with 1 storey in Figure 8. is in Safranbolu Bağlar mah. Hacıbey sokak No: 29. It is the second extension built next to the Safranbolu Kız Meslek Lisesi (Vocational high school for girls). There are flights of stairs to go upstairs. There is a warehouse and a depot on the ground floor. 10 samples were taken from that building. These were supporter, beam and roof materials.

After taking the average values of the samples and being coded as Building 7, a comparison was made on the main chronology of Karabük Blackpine coded 2PINI (EUY %70.3***), Building 7 was dated back to 1924-1961. With respect to this result the wood used for the construction of this house dated back as the closest time to 1953. Since the samples were finished and lack of the latest rings, it could be said that that building might have been constructed after that date (1961).

Building 7 with 1 storey is in Bağlar mah. Hacı Bey sokak. 5 samples were taken. The correlation among the samples was quite high so their mean values were calculated. After making a comparison on the main chronology of Karabük- karaçam (Blackpine) coded 2PINI (EUY %70.3***), the building was dated back to 1924-1961. This proved that the closest construction date could be in 1961. It could be the date of restoration.

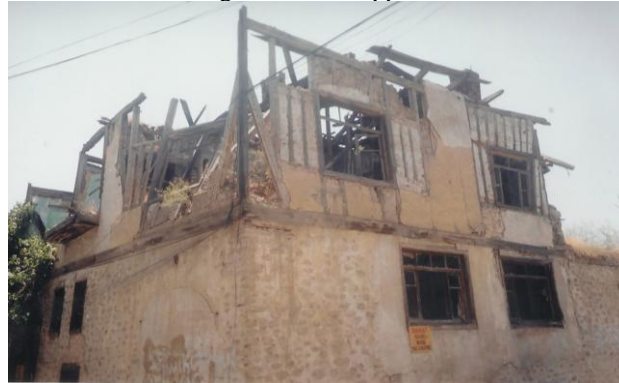
Figure 9. Side view of the house numbered 8.

The house with 2 storeys in Figure 9 is in Safranbolu Kıranköy Barış mah. Utku sokak No: 8. The building was subjected to fire and it has not been accommodated. There is a warehouse and a depot on the ground floor. 10 samples were taken from the building; these are supporter, beam, stair and roof materials.

After taking the average values of the samples and being coded as Building 8, a comparison was made on the main chronology of Karabük Blackpine coded 2PINI (EUY %70.7***), Building 8 was dated back to 1863-1933. With respect to this result the wood used for the construction of this house dated back as the closest time to 1953. Since the samples were finished and lack of the latest rings, it could be said that that building might have been constructed after that date (1933).

Building 8 with 2 storeys is located in Kıranköy Barış mah. Utku Sitesi. The number of taken samples was 6. The correlation among the samples was quite high so their mean values were calculated. After making a comparison on the main chronology of Karabük-karaçam (Blackpine) coded 2 PINI (EUY %70.7***), Building 8 was dated back to 1863-1933. This result certified that the closest date of construction could be in 1933. It could be the date of restoration.

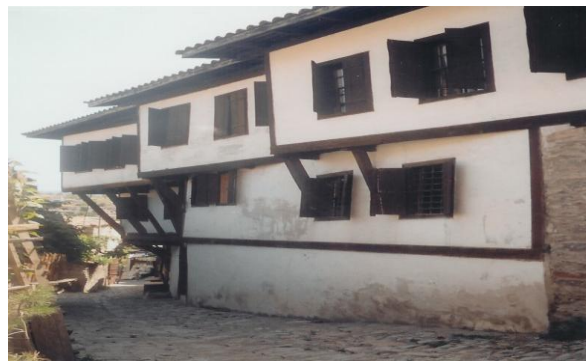
Figure 10. Side view of the building numbered 9.

The house with 2 storeys in Figure 10. is in Safranbolu Eskiçarşı Çeşme mah. Cebeci sokak No: 9. The building was restored. 10 samples were taken from that building; these were supporter, beam, pillar, stair and roof materials.

After taking the average values of the samples and being coded as Building 9, a comparison was made on the main chronology of Karabük Blackpine coded 2PINI (EUY %72.5**), Building 9 was dated back to 1929-2000. With respect to this result the wood used for the construction of this house dated back as the closest time to 1953. With respect to this result it can be said that it was date of restoration rather than the date of construction of the building.

Building 9 with 2 storeys is located in Eski Çarşı Çeşme Mah. behind Arasna. The number of taken samples was 7. The correlation among the samples was quite high so their mean values were calculated. After making a comparison on the main chronology of Karabük-karaçam (Blackpine) coded 2 PINI (EUY %72.4***), Building 9 was dated back to 1929-2000. With respect to this result the year 2000 could be the date of the restoration not the construction date of the building. During the interview with the owners of the house they said that they had the building restored in 2000. They also remembered that the house was subject to the fire three or four times and it is thought that the building was constructed in 1925.

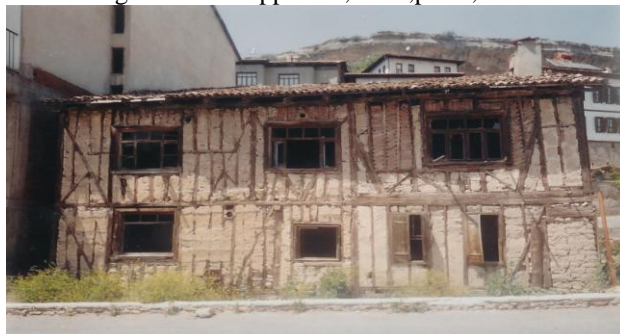
Figure 11. Front view of the house numbered 10.

The house in Figure 11. is in Safranbolu Eskiçarşı Baba Sultan mah. No:11 with 1 storey and is not accommodated. Inner stair flights go upstairs. There is a warehouse and a depot on the ground floor. 10 samples were taken from that building. These are supporter, beam, pillar, window frame and roof materials

After taking the average values of the samples and being coded as Building 10, a comparison was made on the main chronology of Karabük Blackpine coded 2PINI (EUY %70.8**), Building 10 was dated back to 1740-1805. With respect to this result the wood used for the construction of this house dated back as the closest time to 1805. Since the samples were finished and lack of the latest rings, it could be said that that building might have been constructed after that date (1805).

Building 10 with 1 storey is in Eski Çarşı in Baba Sultan Mah. 7 samples were taken. The correlation among the samples was quite high so their mean values were calculated. After making a comparison on the main chronology of Karabük-karaçam (Blackpine) coded 2PINI (EUY %70.8***) it was dated back to 1740-1805. With respect to this result the closest construction date of the building could be in 1805. It is in the same location with İzzet Mehmet Pasha Mosque. The mosque was built in 1796. Their construction dates are very close to each other.

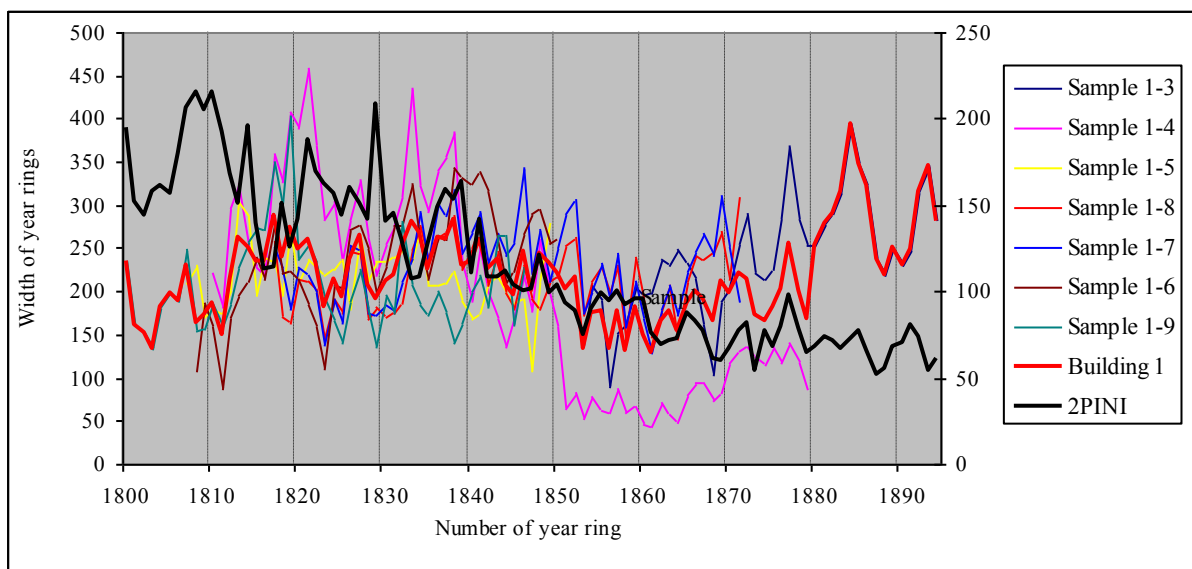
Findings obtained after comparing every sample with each other were given in Figure 12 .The correlation among the samples was quite high so their mean values were calculated (in Figure 12 in bold graph).The correlation persantage (EUY) between the individual graphs and their mean values was given in Table 1.This certified that since the correlation persantage between the graphs was high ,there was a significant concordation among the samples .The correlation of the samples with their mean value is significant at 0.999 reliability degree.

Figure 12. Correlation persantage values (EUY) of the curved lines of the house numbered 1. After taking the mean values of the samples and being coded as Building 1, a comparison was made on the
