**CUTTING TOOL WEAR MECHANISMS WHEN MACHINING PARTICULATE REINFORCED MMCs****İbrahim ÇİFTÇİ\***

**Abstract**

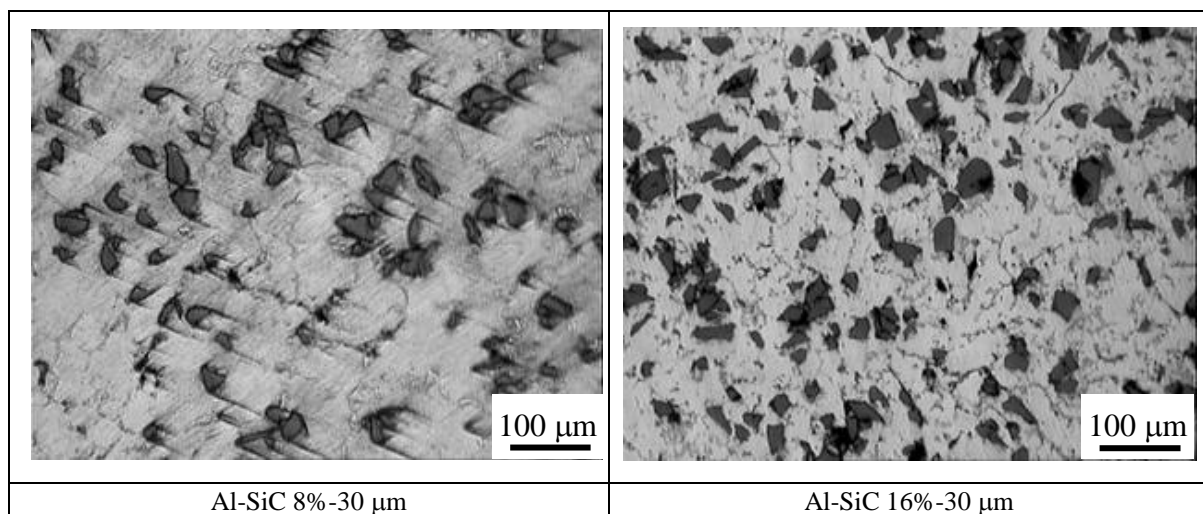
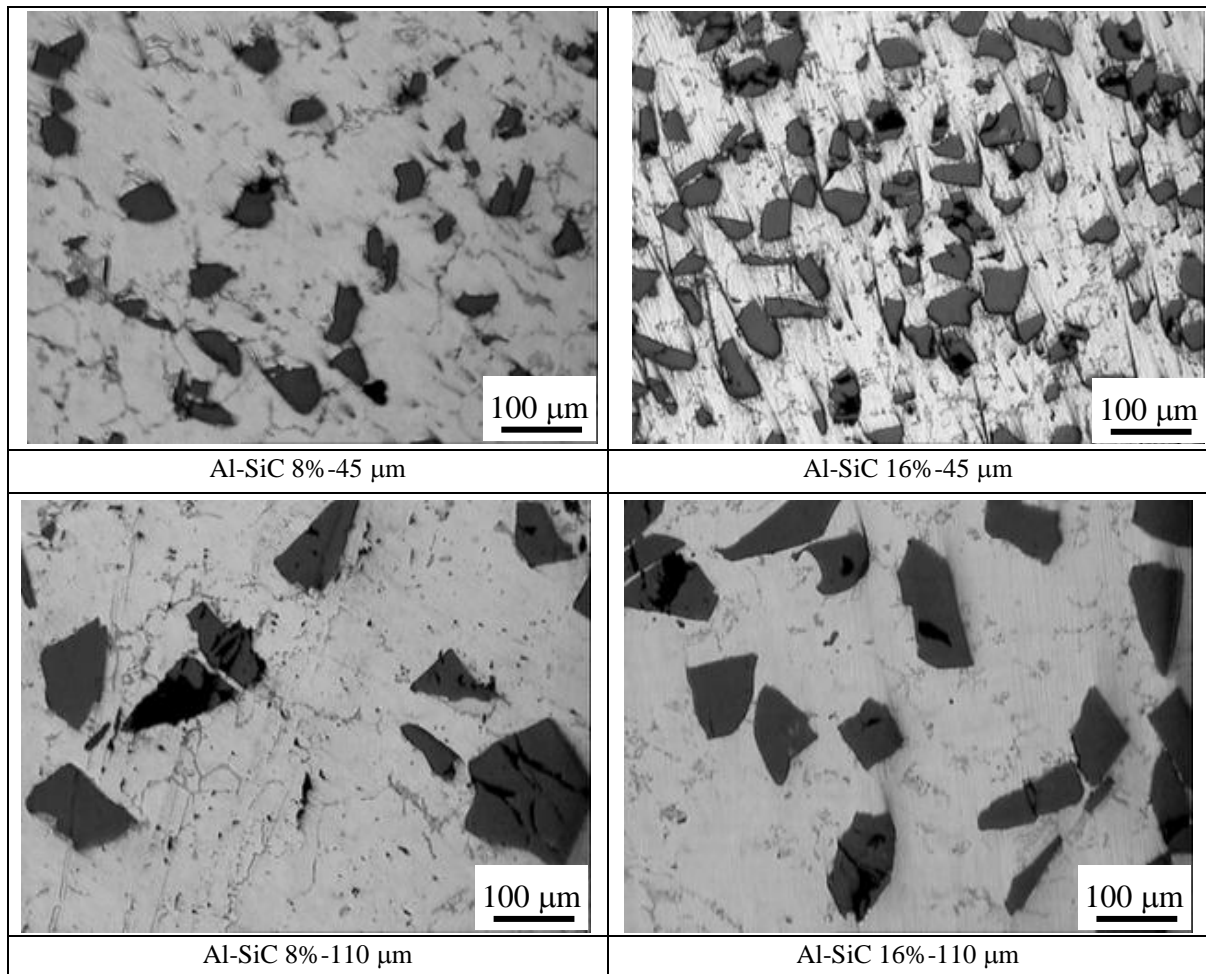
Figure 1. Microstructure of the MMCs

The MMCs were fabricated through a melt stirring-squeeze casting route and contained SiC particles of 30, 45 and 110  $\mu\text{m}$  in mean sizes. The details of which are described elsewhere [2]. The microstructures of the MMCs with different SiC sizes are shown in Fig. 1. The matrix material was a 2014 Al alloy. The chemical composition of the matrix and the list of MMC grades fabricated are given in Table 1 and 2, respectively.

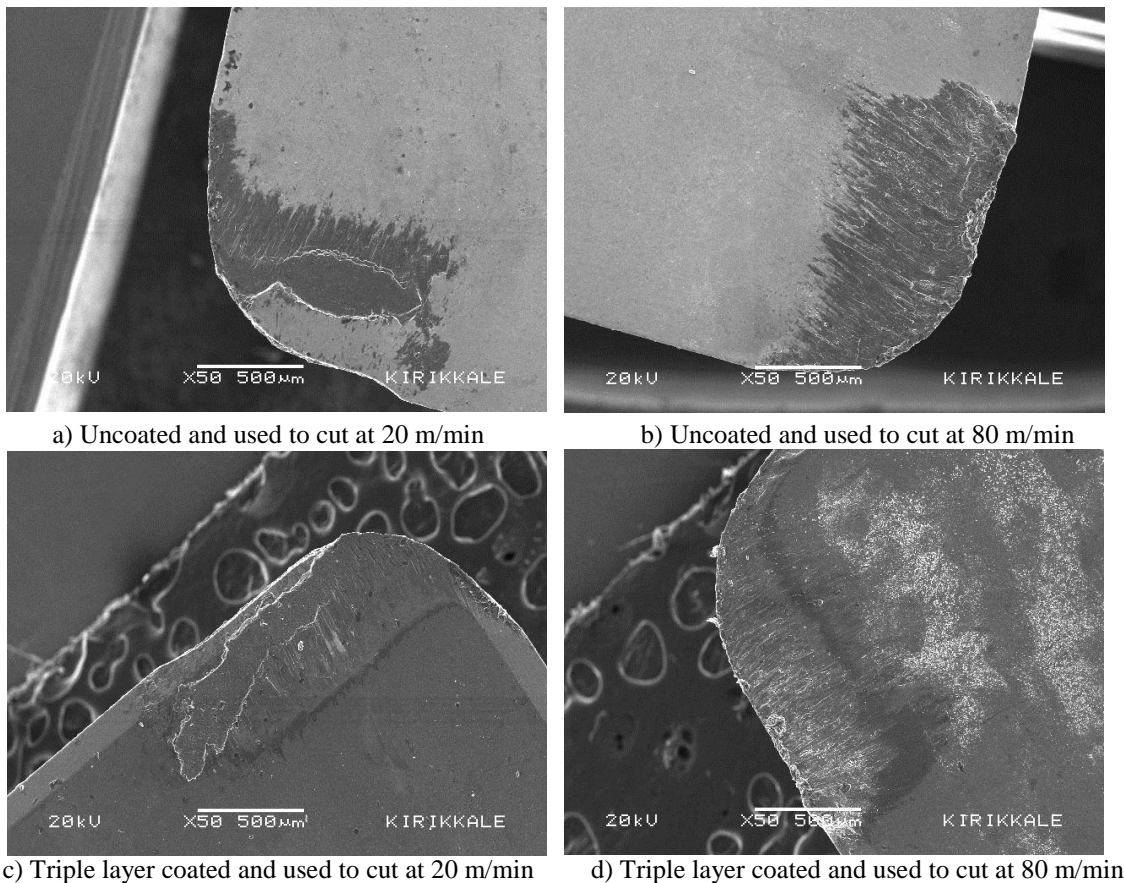
Dominant wear mode of the uncoated and triple layer coated cutting tools was found to be flank wear although negligible crater wear was also observed (Fig. 2). The SEM images in Fig. 2 show both the uncoated and triple layer coated worn tools used to machine Al-SiC 8%-45  $\mu\text{m}$  MMC at 20 and 80 m/min cutting speeds. The images in Fig. 2 a) and c) belong to cutting tools used to machine the MMC at 20 m/min whereas the other images in Fig. 2 b) and d) belong to tools used to machine the MMC at 80 m/min. It can be

deduced from these images that abrasive wear mechanism controlled the tool wear when machining at 20 m/min cutting speed. Abrasive wear is normally characterised by the presence of grooves parallel to the cutting direction on cutting tool flank face. Although the SEM images in this work were taken from the cutting tool rake face, the progressive wear of the cutting edge is the indication of abrasive wear. Abrasive wear of cemented carbide cutting tools in machining of particulate Al-SiC MMCs were also reported by other researchers [12,16,17]. On the other hand, significant edge chipping is shown in Fig. 2 b) and d). High cutting speed was considered to result in edge chipping. It was also reported by Paramanik et al. that [18] impact between particle and tool increases at high cutting speeds and this, in turn, induces easier fracture causing chipping at the cutting edge.

Figure 2. SEM images of the worn uncoated and triple layer coated cemented carbide tools used for machining Al-SiC 8%-45  $\mu\text{m}$  MMC at 20 and 80 m/min cutting speeds [1].

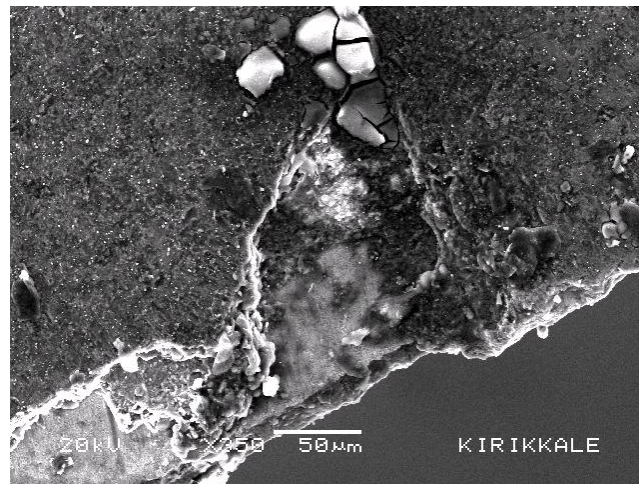
Fig. 3 shows a worn cutting tool used to machine Al-SiC 16%-30  $\mu\text{m}$  MMC at 20 m/min. This SEM image was taken from the rake face of the tool and shows some SiC particles embedded into the cutting tool and fractured. The three-body abrasion is clearly seen from this image.

Figure 3. SEM image of the worn uncoated cemented carbide tool used for machining Al-SiC 16%-30 µm MMC at 20 m/min showing three-body abrasion

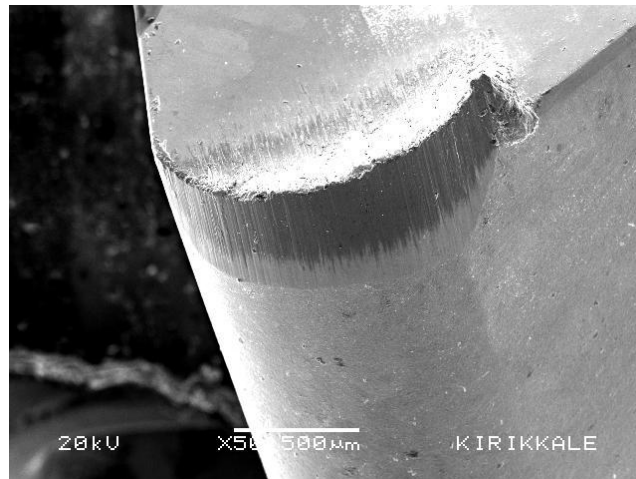
SEM examinations showed that the diamond coating was completely worn away in the cutting zone. Fig. 4 shows the worn cutting tool used to machine Al-SiC 8%-30 µm MMC at 25 m/min cutting speed. From this SEM image, the dominant wear mechanisms can not be seen clearly as the workpiece material adhered to the worn area. This SEM image also shows the built-up edge (BUE) on the cutting edge. In order to observe the wear mechanisms clearly, SEM images at high magnification were also obtained. The images in Fig. 5 were obtained at high magnification for the tools used to cut Al-SiC 16%-45 µm MMC at 25 and 125 m/min cutting speeds. It is seen from these images that the dominant wear mechanisms are mainly abrasive and adhesive at low cutting speed, Fig. 5a. On the other hand, only abrasive mechanism seems dominant at high cutting speed, Fig. 5b.

Figure 4. SEM image of the worn diamond coated cemented carbide tool used for machining Al-SiC 8%-30 µm MMC at 25 m/min.

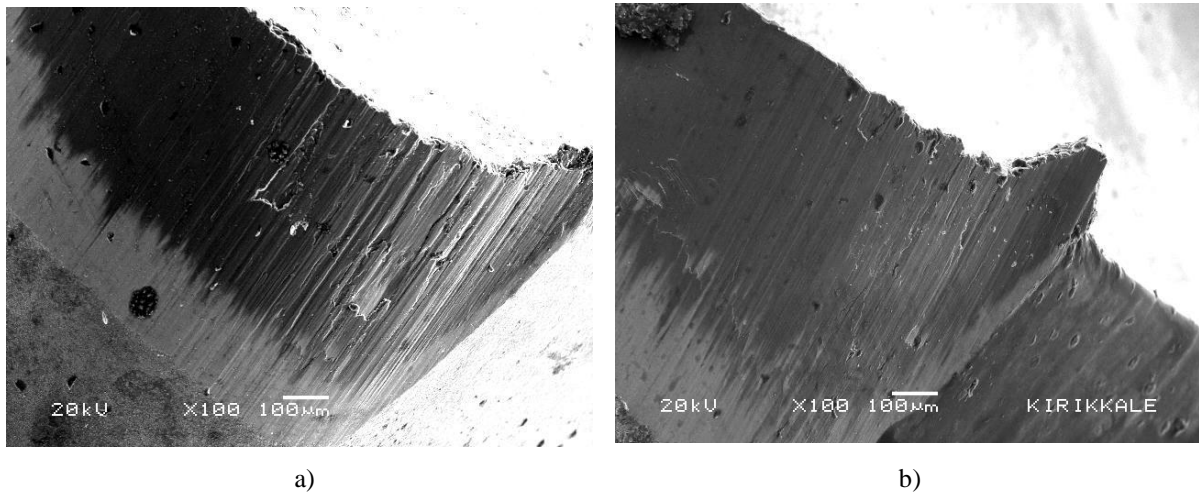
Figure 5. SEM images of the worn diamond coated cemented carbide tools used for machining Al-SiC 16%-45  $\mu\text{m}$  MMC at a) 25 and b) 125 m/min.

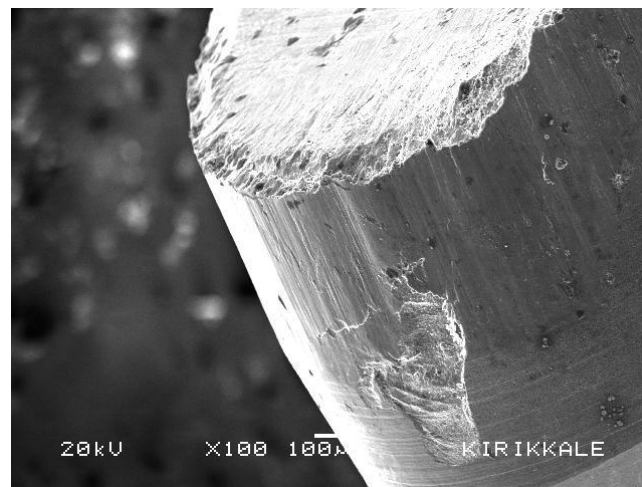
The cutting tools used to machine Al-SiC 16%-110  $\mu\text{m}$  MMC exhibited significant amount of fracture as shown in Fig. 6. This can be attributed to the heavy impact effect of relatively large SiC particles present in the Al-SiC 16%-110  $\mu\text{m}$  MMC.

Figure 6. SEM image of the worn CBN tool used for machining Al-SiC 16%-110  $\mu\text{m}$  MMC at 100 m/min [2]

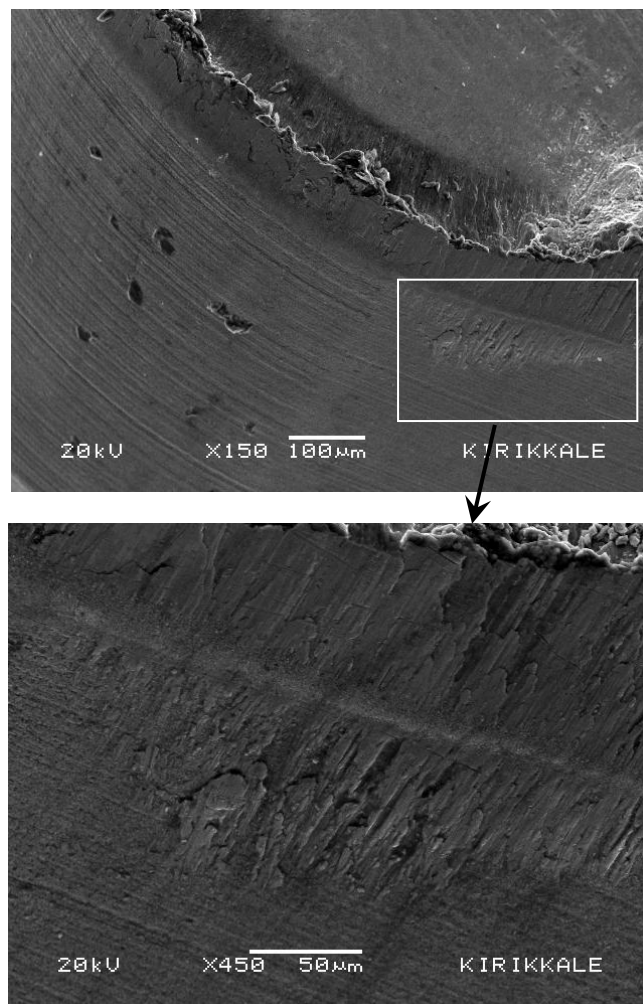
For tools used to machine Al-SiC 16%-30  $\mu\text{m}$  and Al-SiC 16%-45  $\mu\text{m}$  MMCs, the dominant wear mechanisms could not be determined clearly as the workpiece material adhered to the cutting edges at 100 and 150 m/min cutting speed. Andrewes et al. [11] reported that when machining MMCs using PCD cutting tools, the initial flank wear starts with the abrasive effect of the hard particles and the workpiece material adheres to these abrasive grooves strongly due to the high pressure generated at the tertiary cutting zone as machining progresses. Each time, a workpiece film adheres and breaks off as a result of the hard abrasive particles present in the workpiece, small diamond particles are also removed from the PCD cutting tool surface. This cyclic process leads to progressive loss of the PCD tool material. Unlike Andrewes et al. [11], CBN cutting tools were used in this study but it was assumed that similar mechanisms controlled the tool wear during the initial stages. That is because, CBN is close to diamond in hardness and harder than the SiC particles. When the cutting speed was increased to 200 m/min, the mechanisms dominating the tool wear became clear as shown in Fig. 7. Fig. 7 shows the SEM images of tool used to machine Al-SiC 16%-45  $\mu\text{m}$  MMC at 200 m/min. The bottom SEM image in Fig. 7 indicates that that abrasion and adhesion are the mechanisms dominating the tool wear [2].

Figure 7. SEM images of the worn CBN tool used for machining Al-SiC 16%-30  $\mu\text{m}$  MMC at 200 m/min [2]
