CUTTING TOOL WEAR MECHANISMS WHEN MACHINING PARTICULATE REINFORCED MMCs**İbrahim ÇİFTÇİ***

Abstract

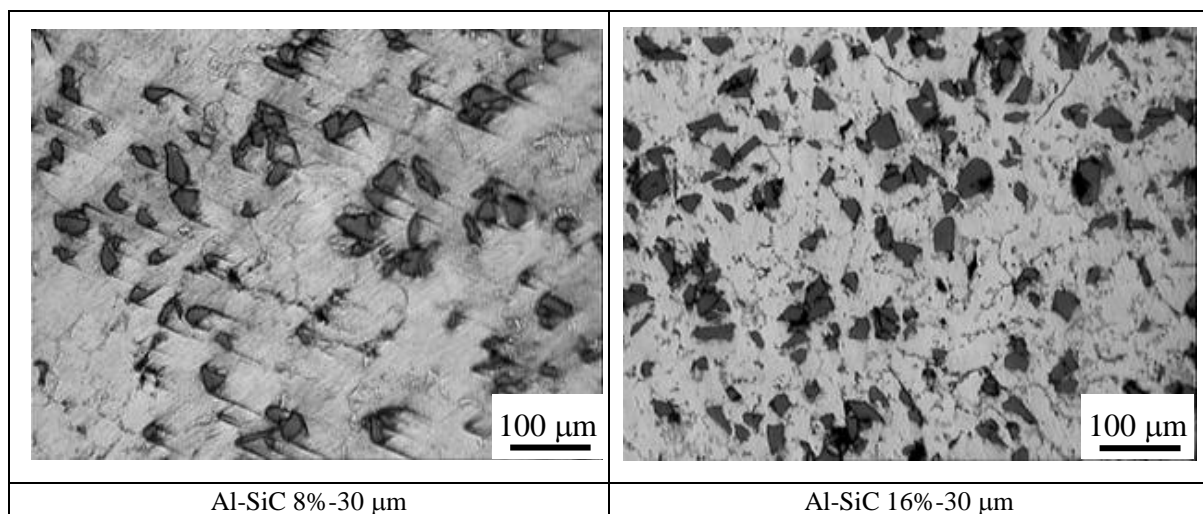
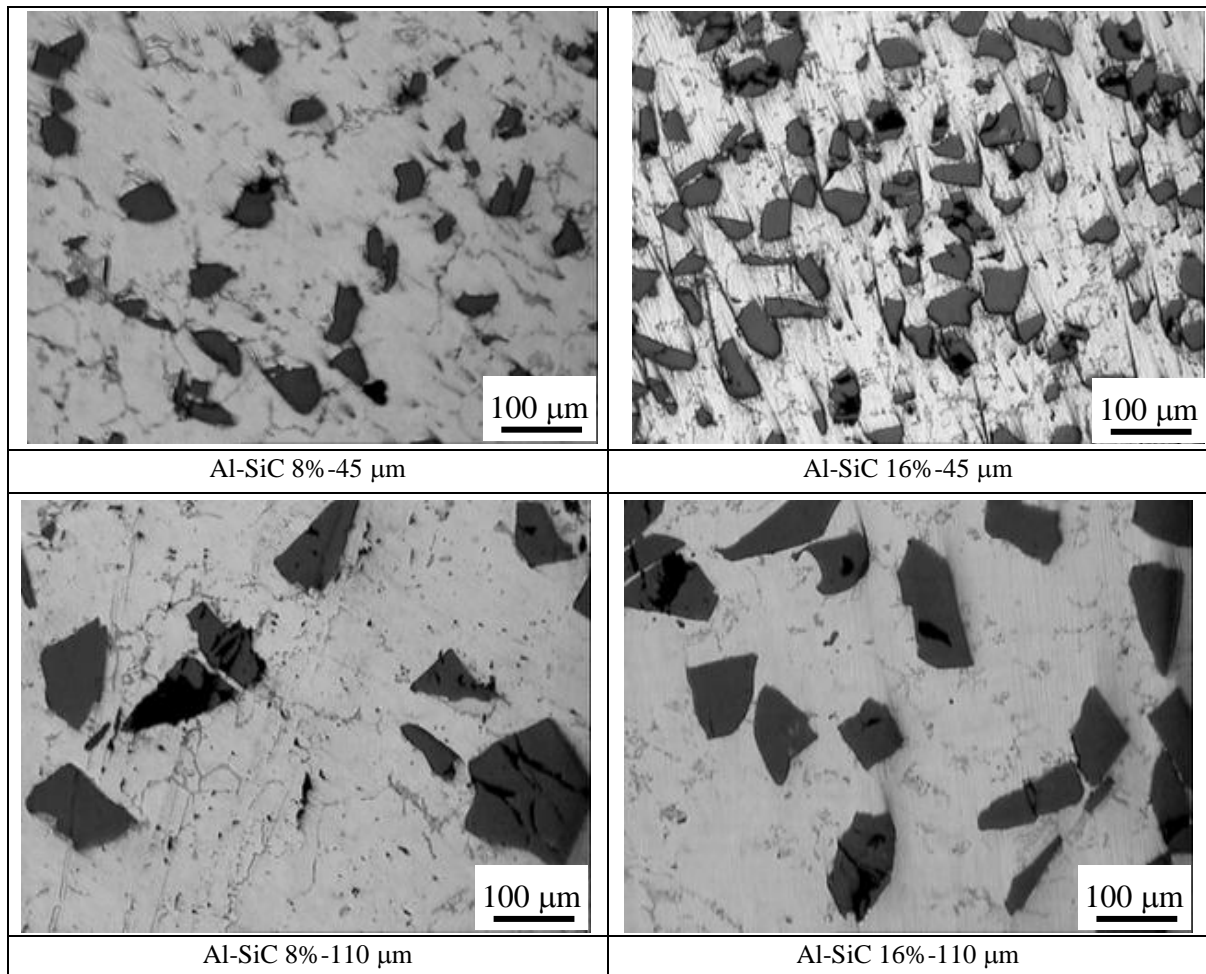
The MMCs were fabricated through a melt stirring-squeeze casting route and contained SiC particles of 30, 45 and 110 μm in mean sizes. The details of which are described elsewhere [2]. The microstructures of the MMCs with different SiC sizes are shown in Fig. 1. The matrix material was a 2014 Al alloy. The chemical composition of the matrix and the list of MMC grades fabricated are given in Table 1 and 2, respectively.

Figure 1. Microstructure of the MMCs

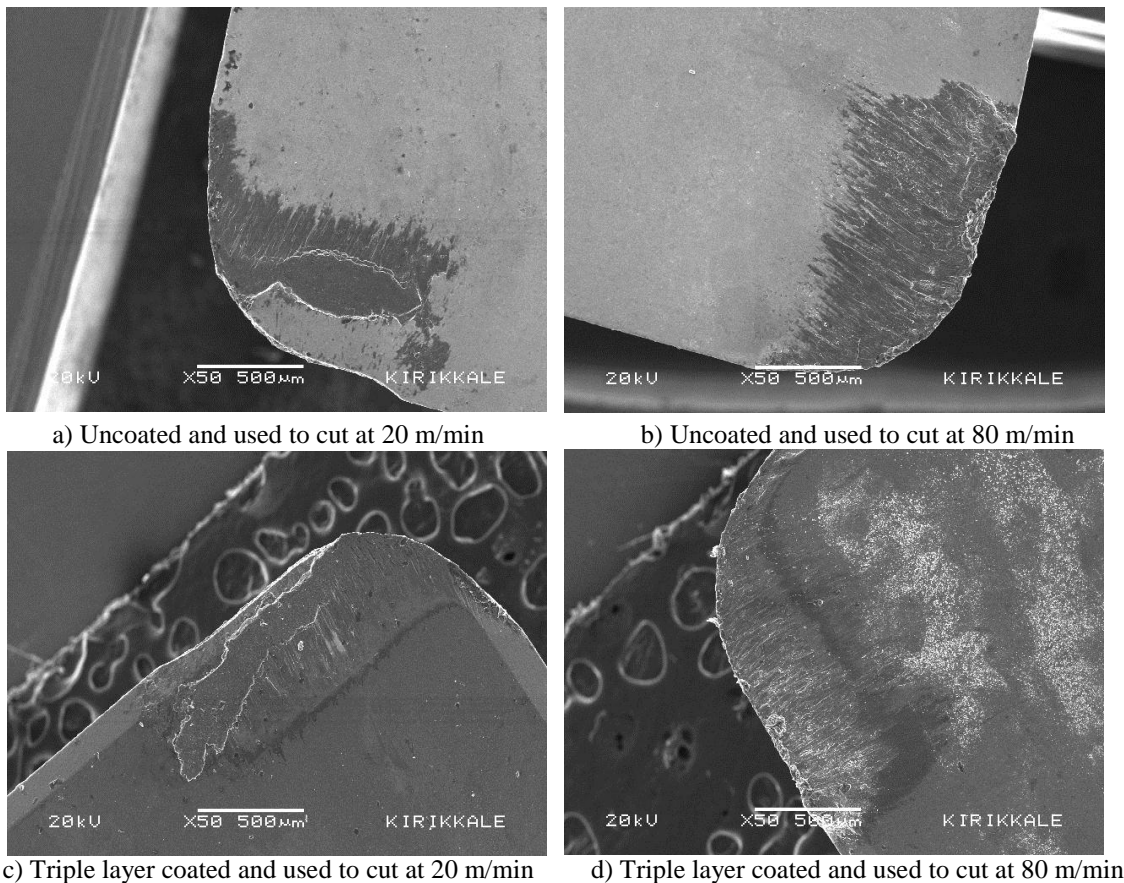
Dominant wear mode of the uncoated and triple layer coated cutting tools was found to be flank wear although negligible crater wear was also observed (Fig. 2). The SEM images in Fig. 2 show both the uncoated and triple layer coated worn tools used to machine Al-SiC 8%-45 μm MMC at 20 and 80 m/min cutting speeds. The images in Fig. 2 a) and c) belong to cutting tools used to machine the MMC at 20 m/min whereas the other images in Fig. 2 b) and d) belong to tools used to machine the MMC at 80 m/min. It can be

deduced from these images that abrasive wear mechanism controlled the tool wear when machining at 20 m/min cutting speed. Abrasive wear is normally characterised by the presence of grooves parallel to the cutting direction on cutting tool flank face. Although the SEM images in this work were taken from the cutting tool rake face, the progressive wear of the cutting edge is the indication of abrasive wear. Abrasive wear of cemented carbide cutting tools in machining of particulate Al-SiC MMCs were also reported by other researchers [12,16,17]. On the other hand, significant edge chipping is shown in Fig. 2 b) and d). High cutting speed was considered to result in edge chipping. It was also reported by Paramanik et al. that [18] impact between particle and tool increases at high cutting speeds and this, in turn, induces easier fracture causing chipping at the cutting edge.

Figure 2. SEM images of the worn uncoated and triple layer coated cemented carbide tools used for machining Al-SiC 8%-45 μm MMC at 20 and 80 m/min cutting speeds [1].

- SEM investigation revealed that tool flank wear was the dominant wear mode for all the cutting tools. On the other hand, machining of the MMC containing relatively large SiC particles (110 μm) using CBN cutting tools resulted in both the cutting edge and nose fractures.
- For the uncoated and triple layer coated cemented carbide tools, abrasive wear mechanism was found to be effective at low cutting speeds and chipping at high cutting speeds. In addition to two-body abrasive wear, three-body abrasive wear mechanism was also clearly observed for the uncoated cemented carbide tool.
- For the CBN and diamond coated cemented carbide cutting tools, abrasion and adhesion were observed as the predominant wear mechanisms.

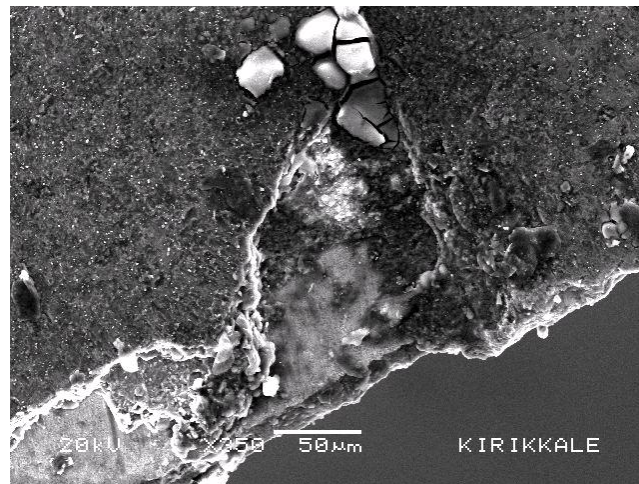
Fig. 3 shows a worn cutting tool used to machine Al-SiC 16%-30 μm MMC at 20 m/min. This SEM image was taken from the rake face of the tool and shows some SiC particles embedded into the cutting tool and fractured. The three-body abrasion is clearly seen from this image.

Figure 3. SEM image of the worn uncoated cemented carbide tool used for machining Al-SiC 16%-30 μm MMC at 20 m/min showing three-body abrasion

Abrasive wear can be effective in two ways: two-body abrasion and three-body abrasion. Two-body abrasive wear can easily be determined from wear grooves on the cutting tool. However, three-body abrasive wear can not easily be determined. Li and Seah [17] reported the occurrence of three-body abrasion of cemented carbide tools in the machining of particulate reinforced MMCs. They stated that the scratches and craters found on the flank wear surface were the indications of three-body abrasion.

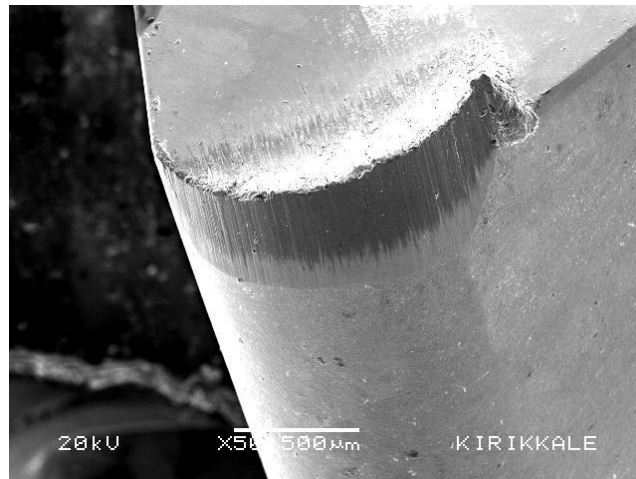
SEM examinations showed that the diamond coating was completely worn away in the cutting zone. Fig. 4 shows the worn cutting tool used to machine Al-SiC 8%-30 μm MMC at 25 m/min cutting speed. From this SEM image, the dominant wear mechanisms can not be seen clearly as the workpiece material adhered to the worn area. This SEM image also shows the built-up edge (BUE) on the cutting edge. In order to observe the wear mechanisms clearly, SEM images at high magnification were also obtained. The images in Fig. 5 were obtained at high magnification for the tools used to cut Al-SiC 16%-45 μm MMC at 25 and 125 m/min cutting speeds. It is seen from these images that the dominant wear mechanisms are mainly abrasive and adhesive at low cutting speed, Fig. 5a. On the other hand, only abrasive mechanism seems dominant at high cutting speed, Fig. 5b.

Figure 4. SEM image of the worn diamond coated cemented carbide tool used for machining Al-SiC 8%-30 μm MMC at 25 m/min.

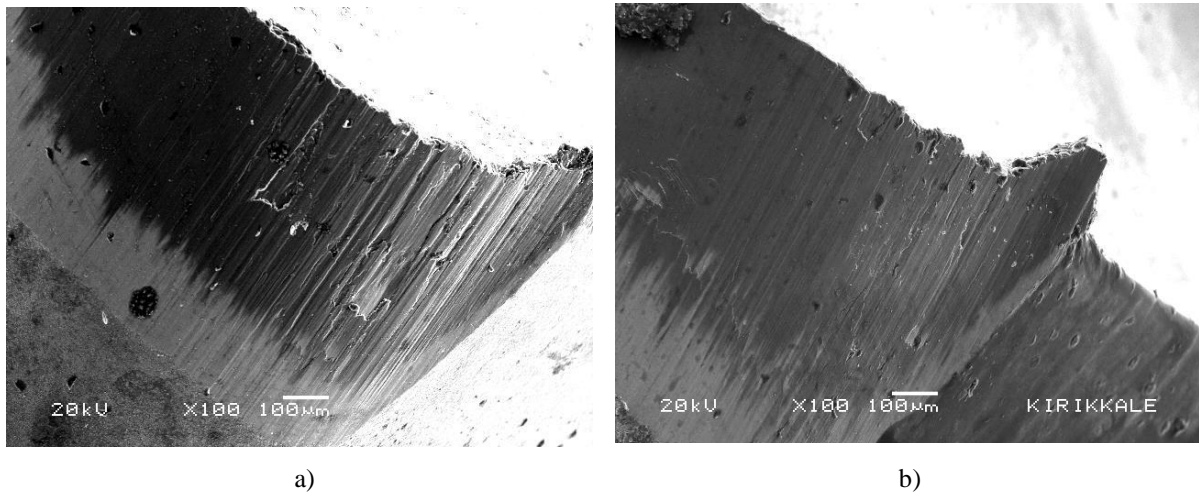
Figure 5. SEM images of the worn diamond coated cemented carbide tools used for machining Al-SiC 16%-45 μm MMC at a) 25 and b) 125 m/min.

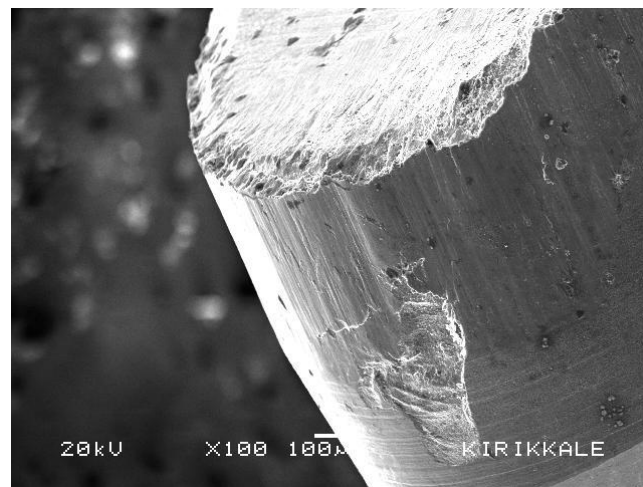
The cutting tools used to machine Al-SiC 16%-110 μm MMC exhibited significant amount of fracture as shown in Fig. 6. This can be attributed to the heavy impact effect of relatively large SiC particles present in the Al-SiC 16%-110 μm MMC.

Figure 6. SEM image of the worn CBN tool used for machining Al-SiC 16%-110 μm MMC at 100 m/min [2]

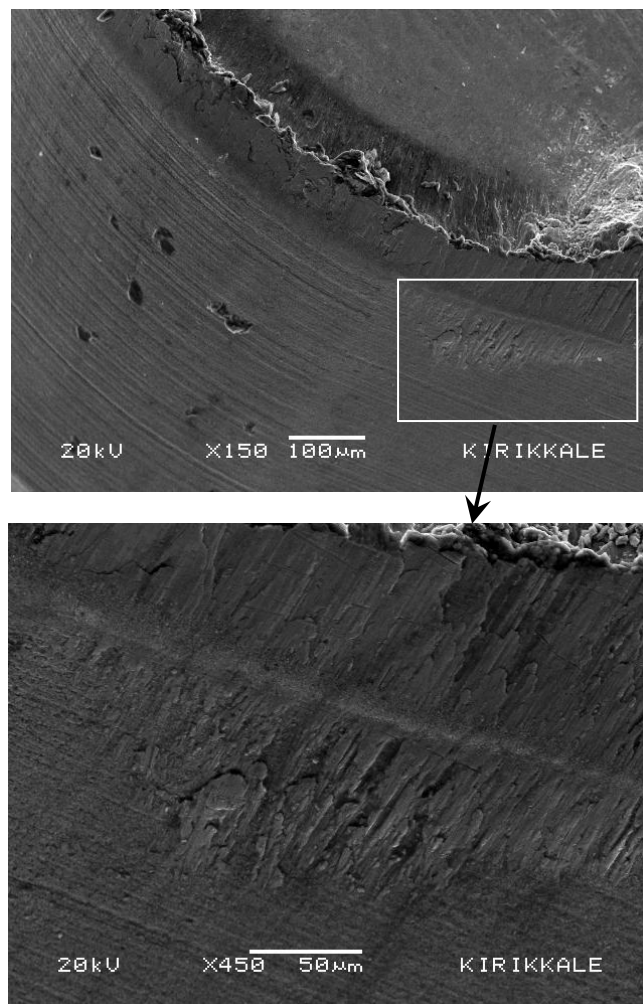
For tools used to machine Al-SiC 16%-30 μm and Al-SiC 16%-45 μm MMCs, the dominant wear mechanisms could not be determined clearly as the workpiece material adhered to the cutting edges at 100 and 150 m/min cutting speed. Andrewes et al. [11] reported that when machining MMCs using PCD cutting tools, the initial flank wear starts with the abrasive effect of the hard particles and the workpiece material adheres to these abrasive grooves strongly due to the high pressure generated at the tertiary cutting zone as machining progresses. Each time, a workpiece film adheres and breaks off as a result of the hard abrasive particles present in the workpiece, small diamond particles are also removed from the PCD cutting tool surface. This cyclic process leads to progressive loss of the PCD tool material. Unlike Andrewes et al. [11], CBN cutting tools were used in this study but it was assumed that similar mechanisms controlled the tool wear during the initial stages. That is because, CBN is close to diamond in hardness and harder than the SiC particles. When the cutting speed was increased to 200 m/min, the mechanisms dominating the tool wear became clear as shown in Fig. 7. Fig. 7 shows the SEM images of tool used to machine Al-SiC 16%-45 μm MMC at 200 m/min. The bottom SEM image in Fig. 7 indicates that that abrasion and adhesion are the mechanisms dominating the tool wear [2].

Figure 7. SEM images of the worn CBN tool used for machining Al-SiC 16%-30 μm MMC at 200 m/min [2]
